F-4-23

John Harmon Remsberg Farmstead
Middletown vicinity
Private

Ca. 1857-1940

Maryland Historical Trust State Historic Sites Inventory Form

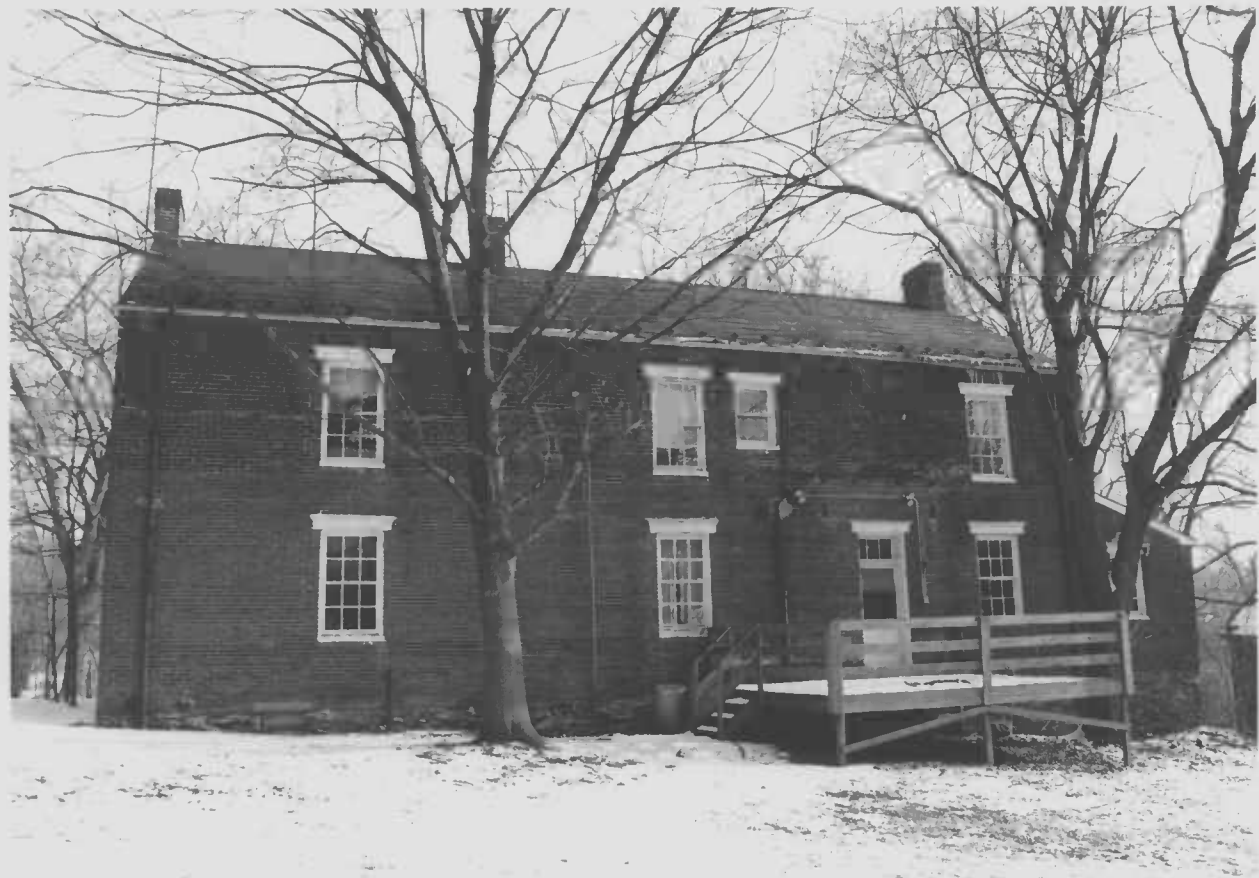
5/2

Southwest elevation

The dwelling faces northeast and is set back from Holter Road across a small creek which passes through the property to a pond south east of the house. The house has two sections, a two bay, two-story main part with a side-by-side two-story brick wing built at the same time. Both sections are in 5:1 American bond with a corbeled brick cornice. The main section has two bays with the entrance in the inner bay and a one-story porch with turned columns across the entire facade. The window openings have molded wood lintels, wood sills, 6/6 sash, and louvered shutters. The doorway has a three-light transom and the door has arched molding panels. The roof is composition material and the main section has two chimney stacks, one enclosed by the adjoining wing. The wing has an integral two-story porch with square posts and a scroll-sawn decorative balustrade on the second level. Four bays in the wing's northeast elevation have two entrances in the inner bays. These have paneled soffits and three-light transoms, and the window openings have molded lintels as on the main section. The sash is 6/6. An interior end chimney rises at the south gable end. On the flat rear or southwest elevation are three widely spaced bays with an added bathroom window on the second floor. The rear doorway from the wing has a modern wood deck. A cellar entrance is located on the south gable end. On the southwest corner is a brick extension, perhaps a storage room, on a raised stone foundation. It has a window on the southwest side and a shed roof. The interior was not accessible for this survey.

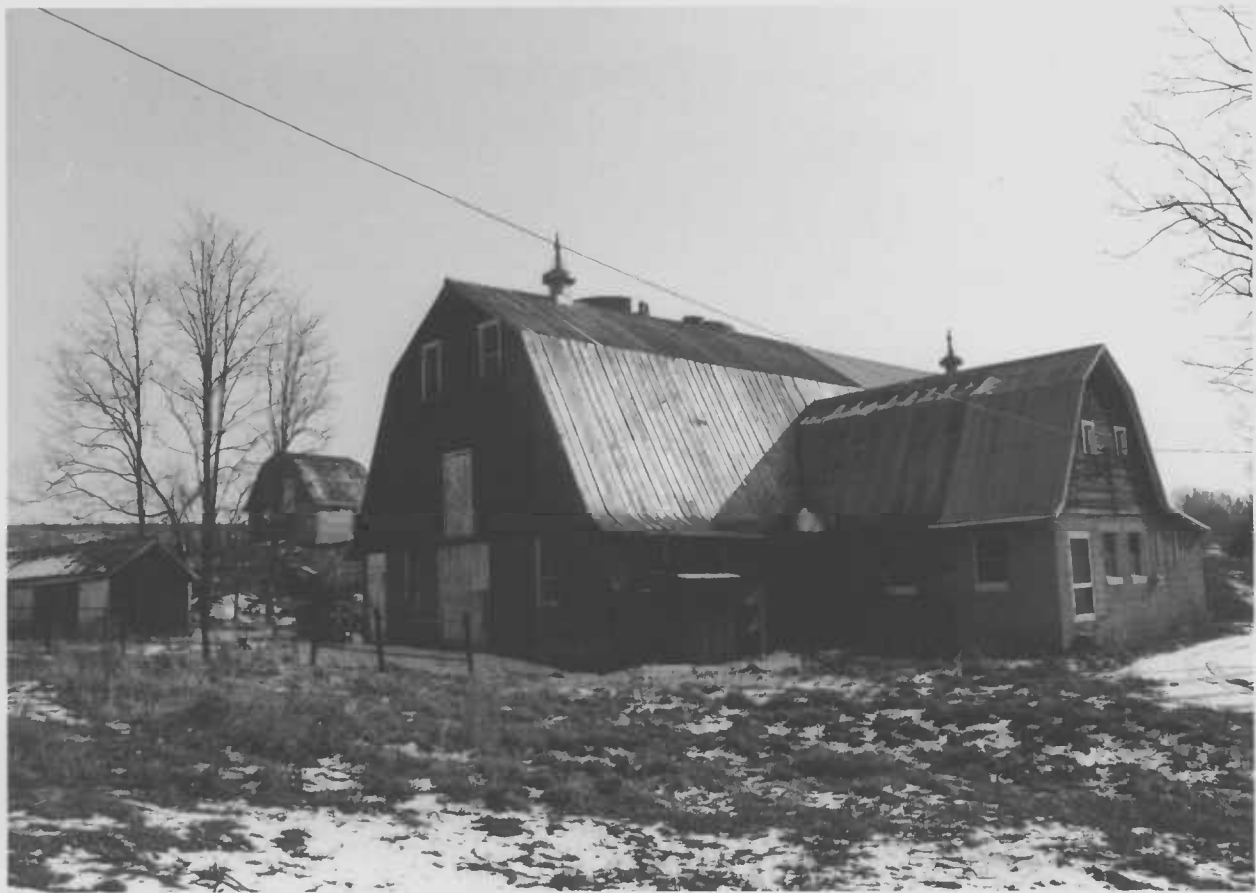
3/5

Dairy Barn, South side of

Dairy barn: The dairy barn has two sections, a 1923 rusticated concrete block main part with a standing seam metal gambrel roof and decorative metal ridge ventilators. The gable ends are covered with german siding. A plain concrete block extension on the long south elevation was added in 1937, probably to facilitate an expansion in dairy operations. Two concrete silos are located on the north side of the barn and probably date from the same period, 1923-1937.

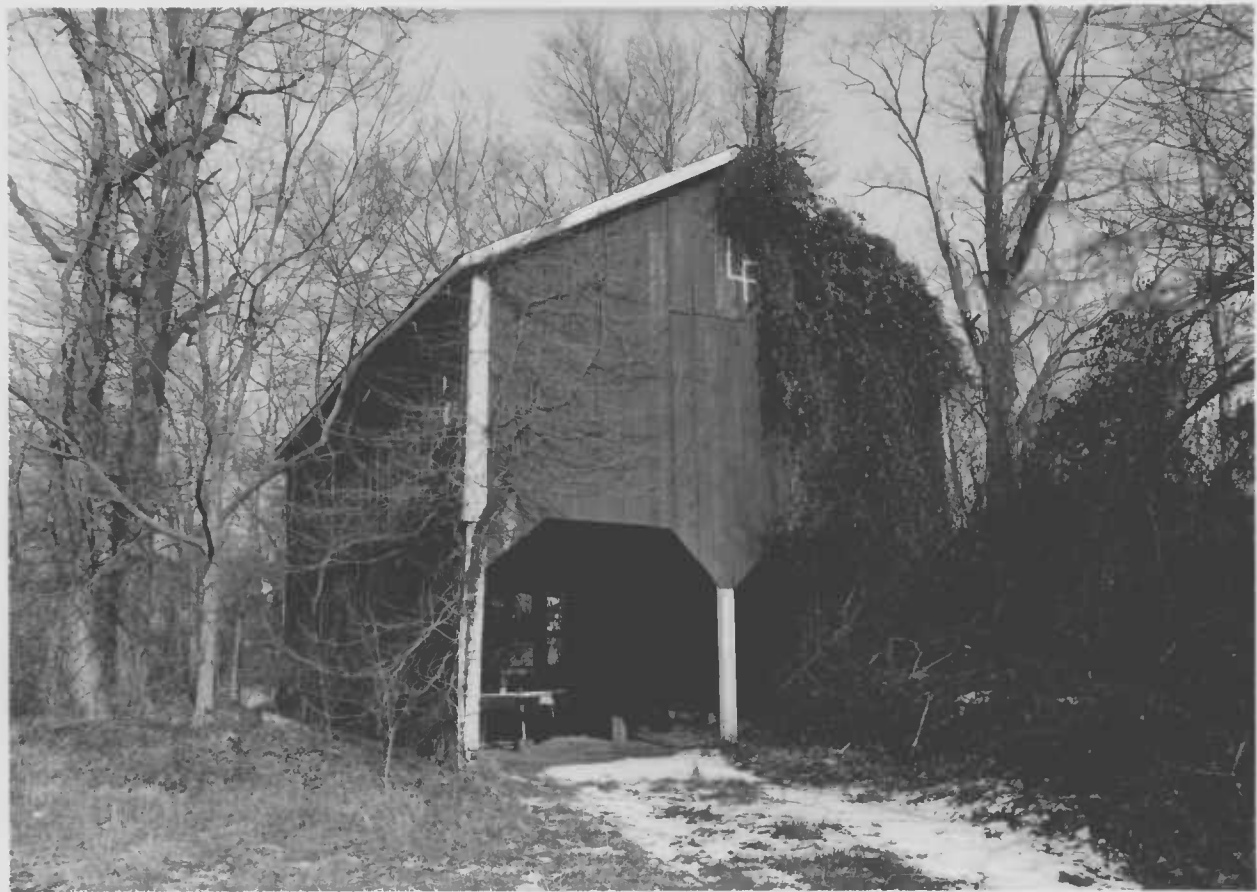
5/6

Wagon 5 1/2" / 1000 x 18, View from southeast

Corn crib/wagon shed: The two-level corn crib and wagon shed built about 1930-35 is located near Holter Road with the shed at road level. The upper level, with a ramp on the north elevation, is the granary. According to Mr. Remsberg, the structure was built when Holter Road was relocated to the south, and the former roadbed against the excavated hillside was built over to form the lower level shed. The shed has double drive-through spaces. On the upper vertical board siding are the painted monograms "LF", symbolizing the name "Locvale Farm", which was given to the farm by J. Homer Remsberg, the owner from 1926 to 1976.
